**TEST REPORT NO. 6026-S2-NZ-2014**

# ZENDOW UPVC FRENCH INWARD CASEMENT WITH TILT-TURN WINDOW PROTOTYPE TEST to NZS 4211-2008

# **DECEUNINCK**

**March 2019**

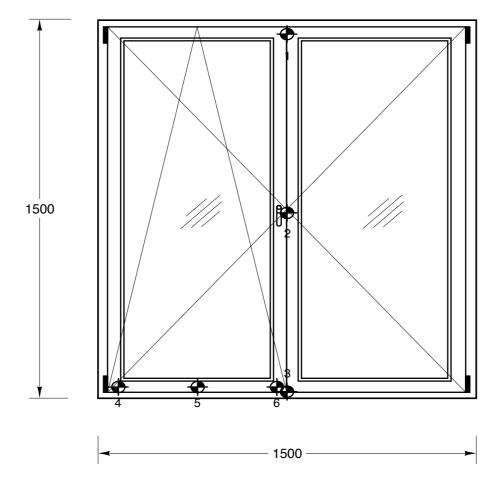
Figure 1. Indoor view of the test sample showing the displacement measurement locations.

Requirement span/200		
Pressure (Pa)	+2310	-2310	
MULLION			
Deflection	Span/256	Span/245	
SASH BOTTOM RAIL			
Deflection	Span/1487	Span/6936

All test readings and calculated deflections are given in Table 1 and measurement locations are indicated on Figure 1.
