TEST REPORT NO. 6044-S1-NZ-2014

WINSA/EVEREST 8848 UPVC TILT-TURN & FIXED WINDOW PROTOTYPE TEST to NZS 4211-2008

DECEUNINCK

March 2019

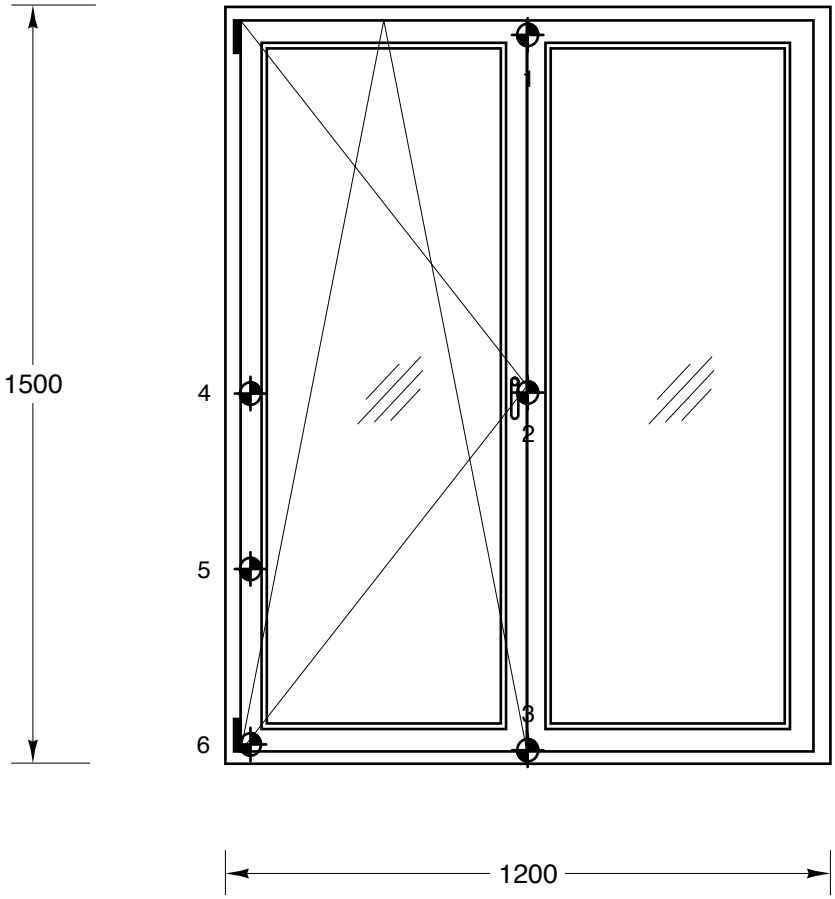
Figure 1. Indoor view of the test sample showing the displacement measurement locations.

All test readings and calculated deflections are given in Table 1 and measurement locations are indicated on Figure 1.

1. Mullion - top
2. Mullion - centre
3. Mullion - bottom
4. Sash Stile - top at lock
5. Sash Stile - midspan
6. Sash Stile - bottom at lock
